CALSPAN ON-SITE AIR BAG DEPLOYMENT INVESTIGATION

CALSPAN CASE NO. 93-8

VEHICLE #1 - 1991 CHEVROLET CORSICA LT (AIR BAG-EQUIPPED)

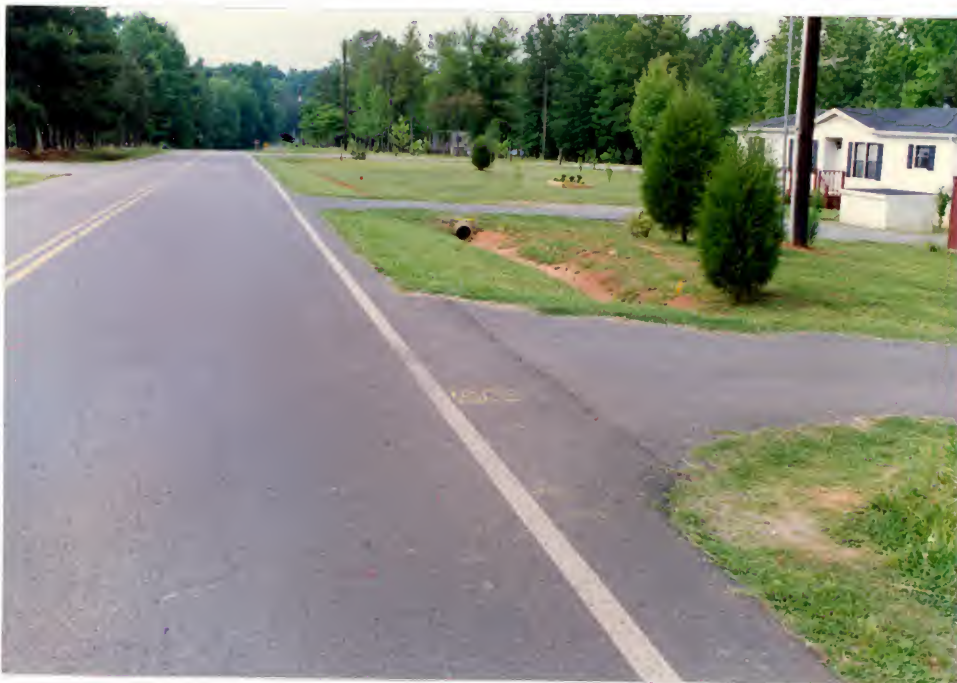
6. Pre-crash trajectory - 15 meters ( 50') prior to the POI.

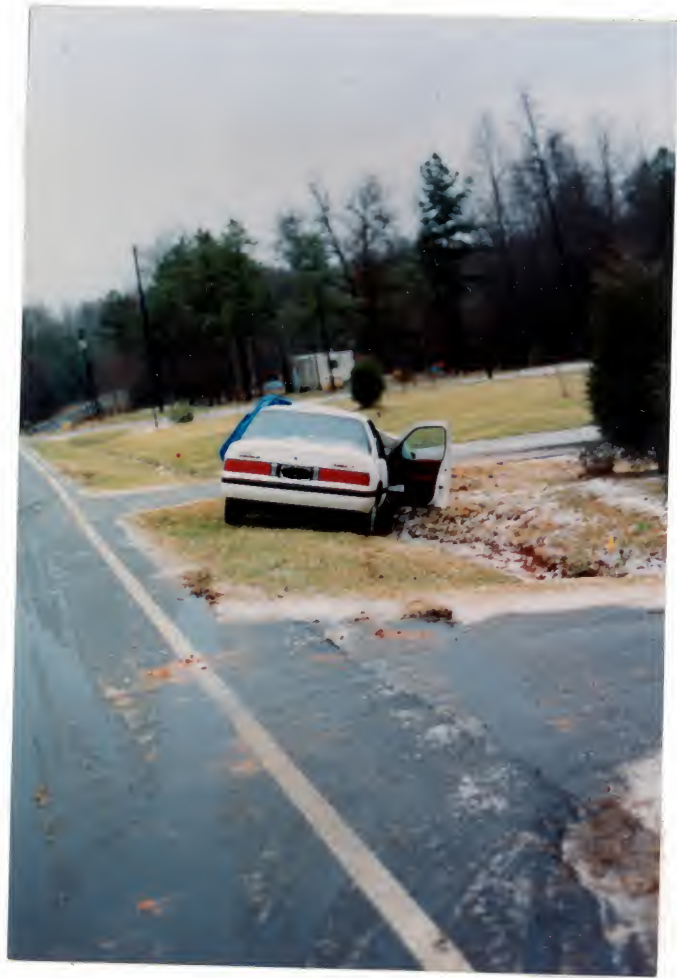
shoulder (i.e., displacement of slush and sod) observed in on-scene photographs taken indicated the vehicle was tracking while traveling in a clockwise trajectory (refer to photograph #7). The sod appeared to be displaced in the direction of vehicle travel which was indicative of driver braking.

7. On-scene pre-crash trajectory 15 meters ( 50') prior to the POI.

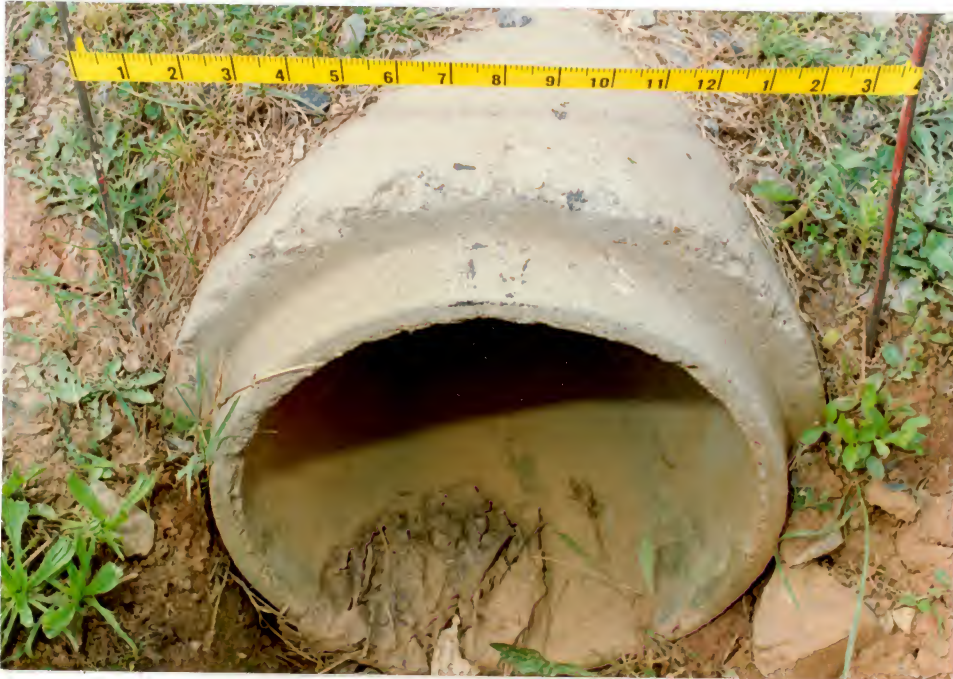
Following maximum engagement with the culvert, the vehicle overrode the drainage pipe as noted by black undercarriage transfer marks on the top surface of the pipe as shown in photographs #11 and #12. It continued to final rest position (FRP) approximately 0.9 cm (3.0') from the POI.

11. Close-up view of driveway culvert with yellow calibrated inch tape installed and depicting the overall pipe diameter of 40.6 cm (16.0").

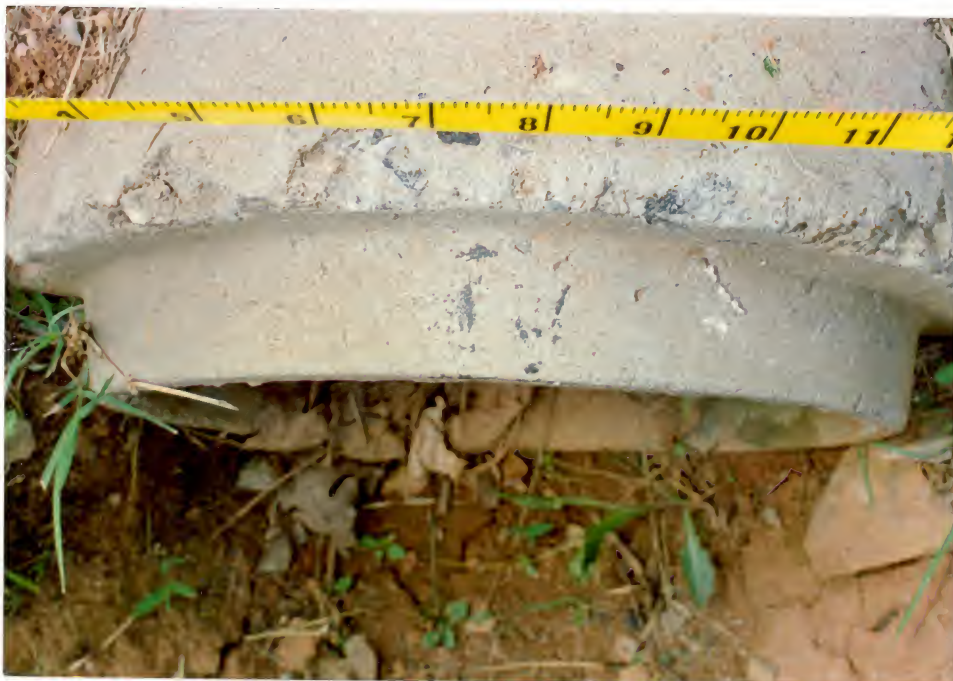
12. Overhead close-up view of driveway culvert showing black transfer marks from the vehicle's undercarriage.

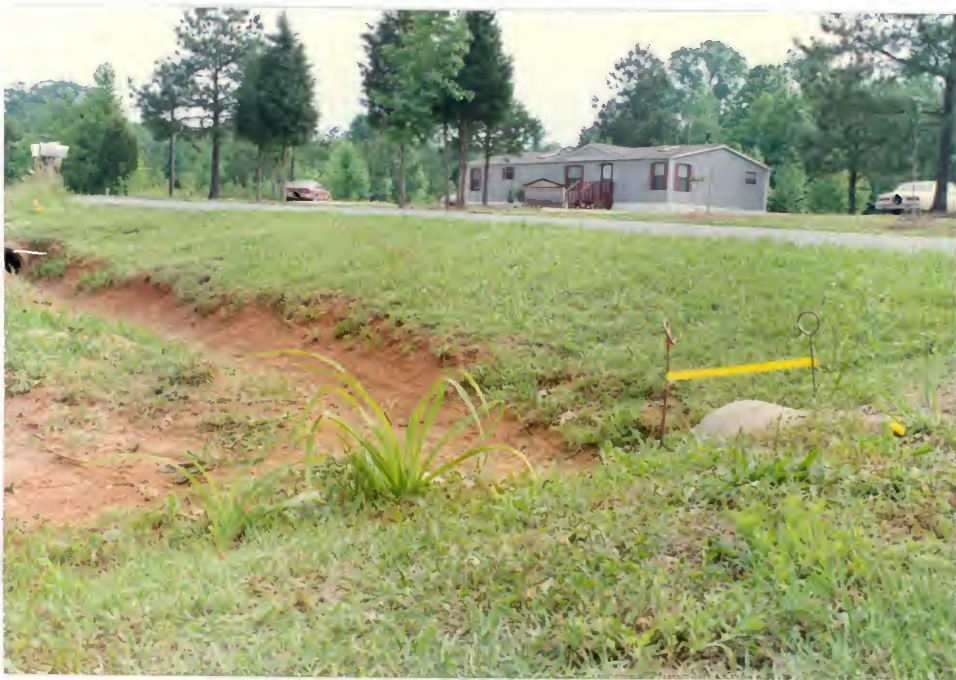
16. Lookback view showing the 11 degree (19 percent) roadside cross slope.

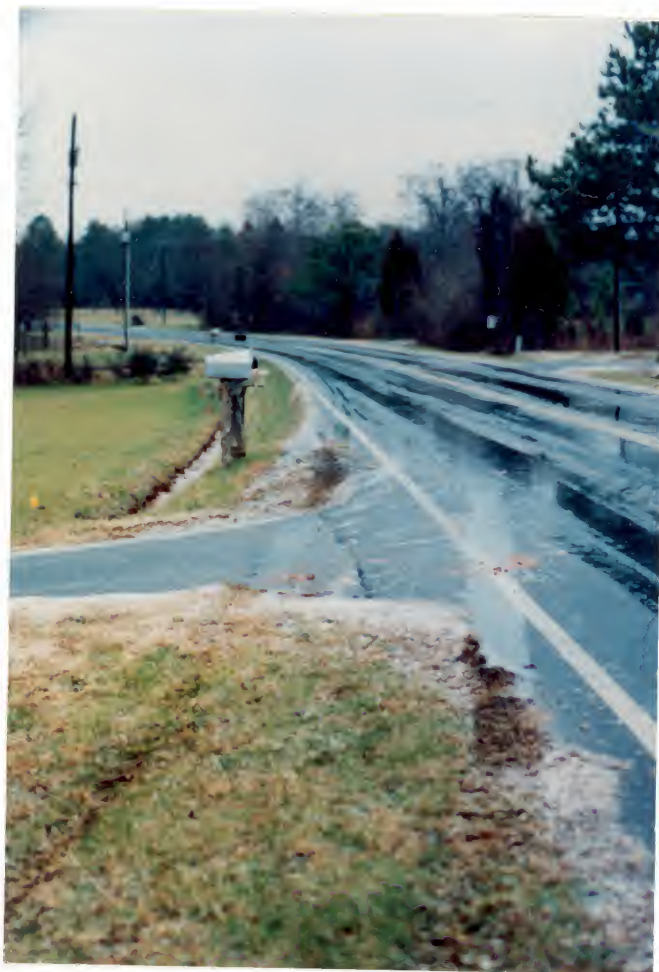
17. On-scene look back showing vehicle departure tire marks in the slush and grass shoulder.

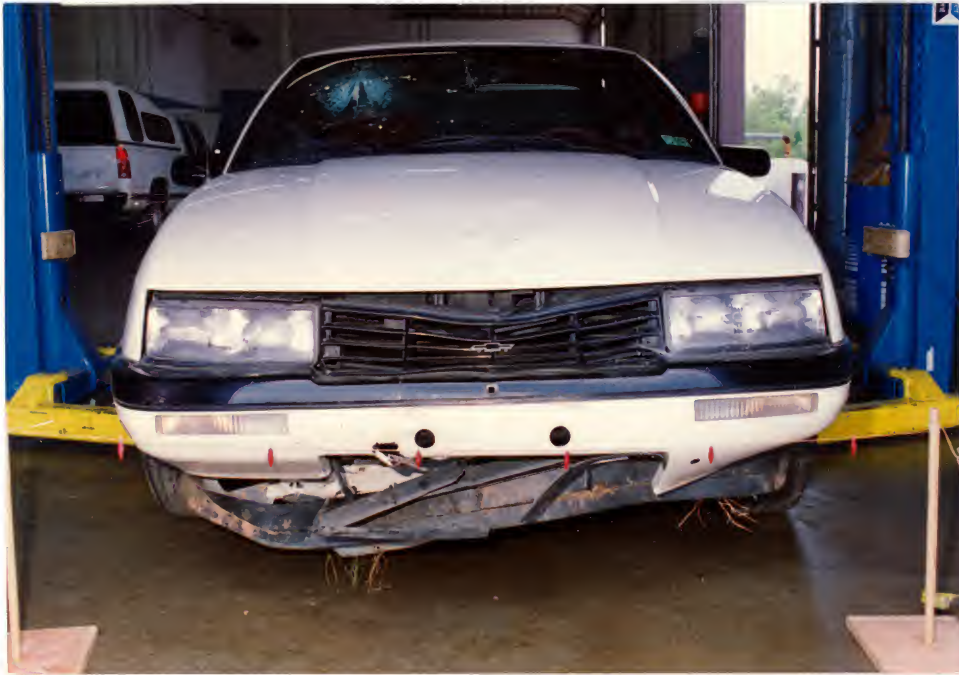
The right frontal plane of the 1991 Chevrolet Corsica LT impacted an open end of a 40.6 cm (16.0") drainage pipe which was designed to channel water under a residential driveway. Direct contact began 2.5 cm (1.0") right of the vehicle's centerline and extended 40.6 cm (16.0") toward the right front corner. The impact displaced the entire frontal structure rearward resulting in a combined direct and induced damage length of 135 cm (53"). Crush values obtained along the front bumper and along the lower radiator support frame member are listed below:

21. Overall view of the 1991 Chevrolet Corsica's frontal plane showing contact damage to the bumper and lower valence panel.

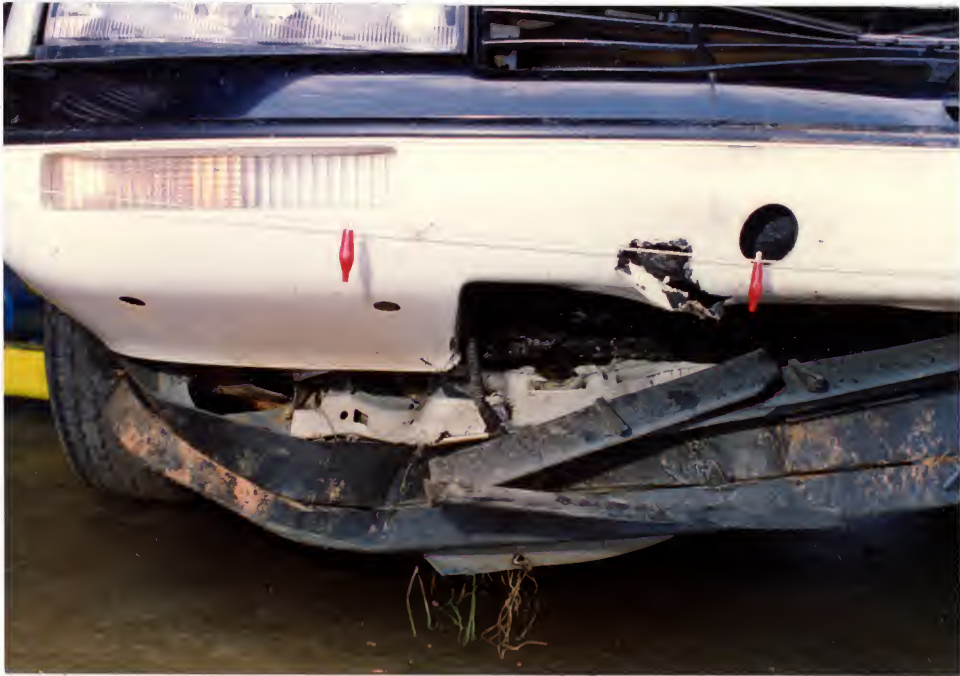
23. Close-up of contact damage on the bumper and lower valence panel.

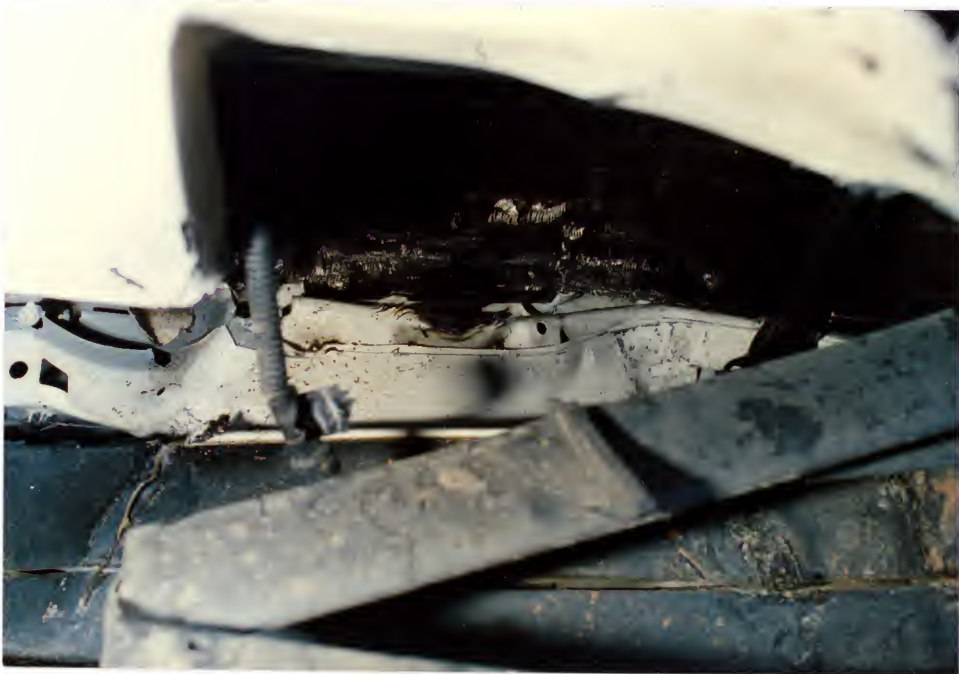
24. Close-up of the lower valence panel and radiator highlighting the contact pattern consistent with the driveway culvert design and dimension.

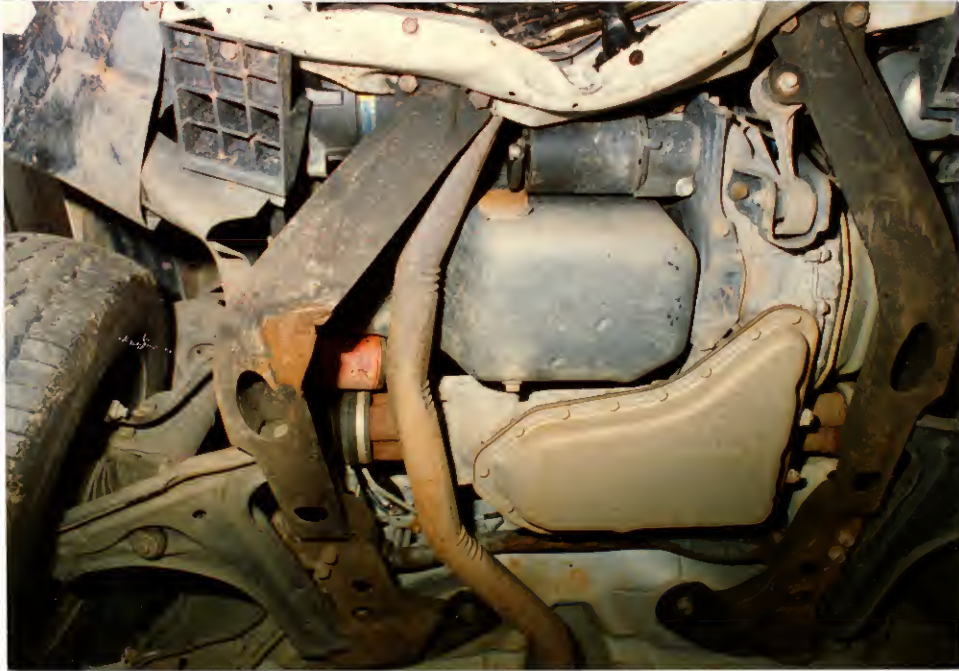
Components damaged in the crash included the front bumper, lower valence/air dam, radiator support bracket, radiator, both frame rails, grille panel, and windshield. The engine frame rails were displaced rearward with the right rail moved 11.4 cm (4.5") rearward and the left rail 2.5 cm (1.0") rearward. The right wheelbase was reduced by 2.3 cm (0.9"). The front bumper energy absorption devices (EAD) compressed during the crash with 1.6 cm (0.6") of stroke noted on the right side and 1.0 cm (0.4") of stroke on the left side. Both EADs returned to full restitution at 11.4 cm (4.5").

29. View of undercarriage showing rearward displacement of frame rails. The top of the photo shows the culvert contact damage on the front lower valence panel while the right frame rail is seen along the left side of the photograph.

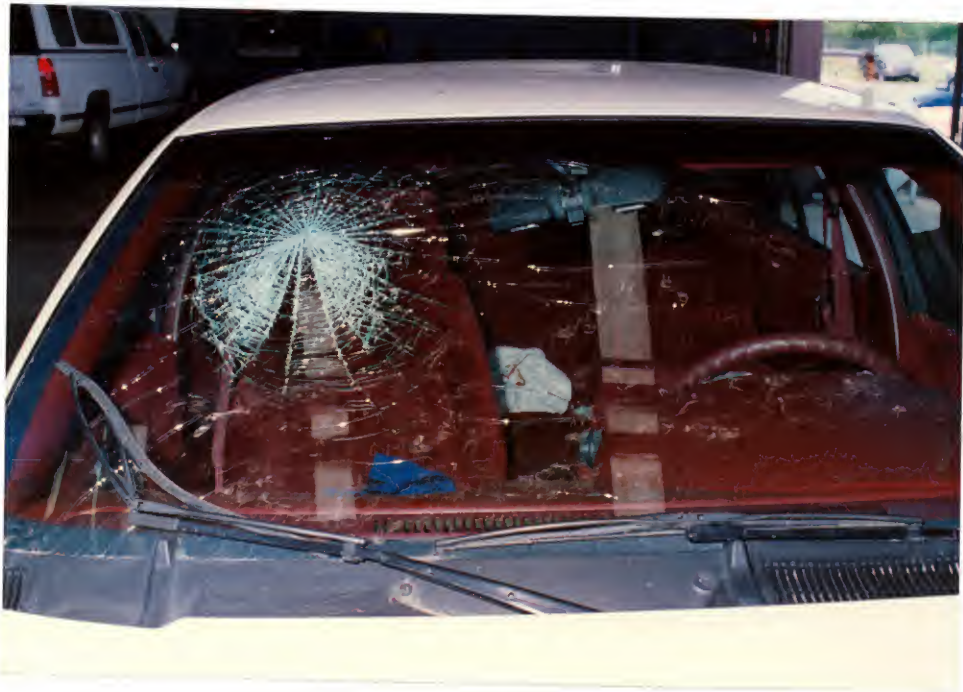
32. View of windshield contact by right front occupant.

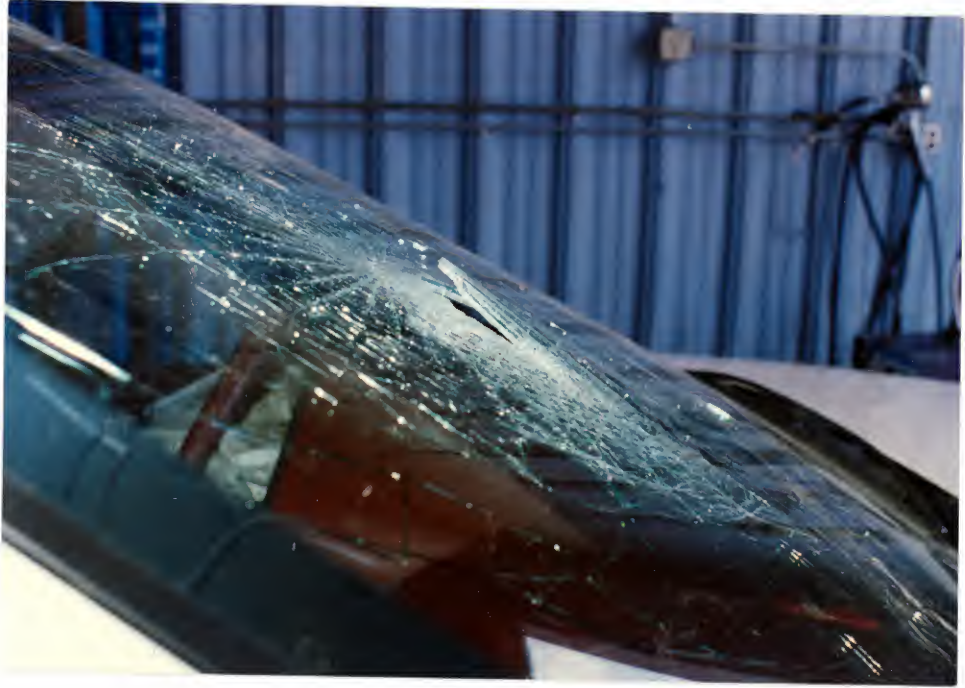
The right front passenger moved forward and contacted the instrument panel with her knees and windshield with her head which resulted in a 7.6 cm (3.0") by 6.4 cm (2.5") tear of the windshield laminate. She sustain an avulsion, abrasions, and contusions of the forehead and an avulsion and contusion of the right knee. Witnesses (residents of the area) found the

33. Close-up lateral view showing windshield laminate tear from contact by right front occupant.

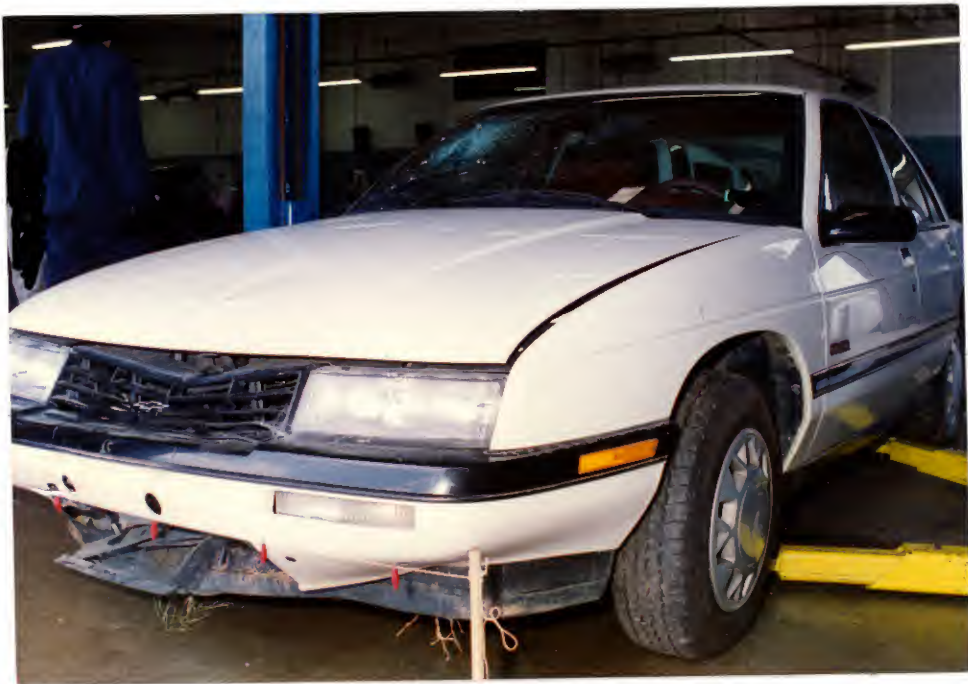
34. Left front corner view showing impact damage.

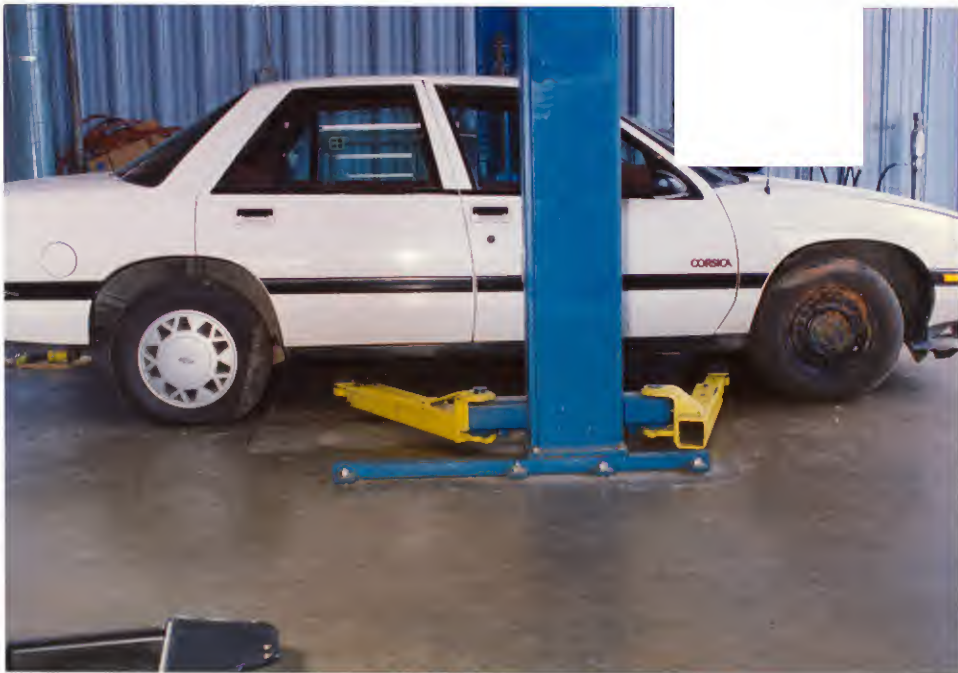
40. View of right side plane showing ditch contact evidence on the right front tire and wheel.

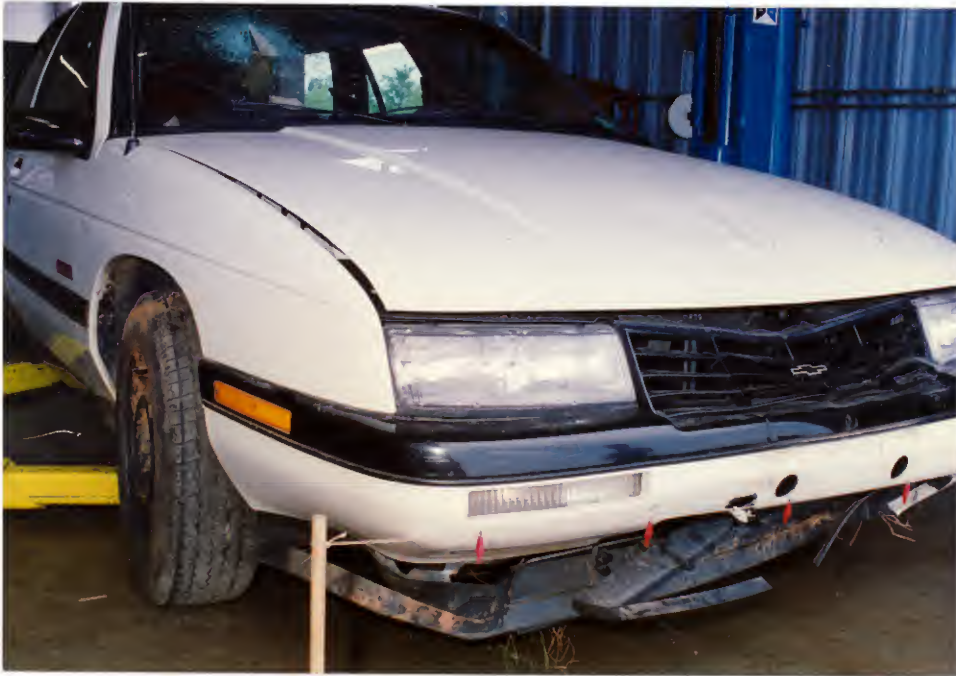
41. Right front corner view showing contact damage to bumper and lower valence panel.

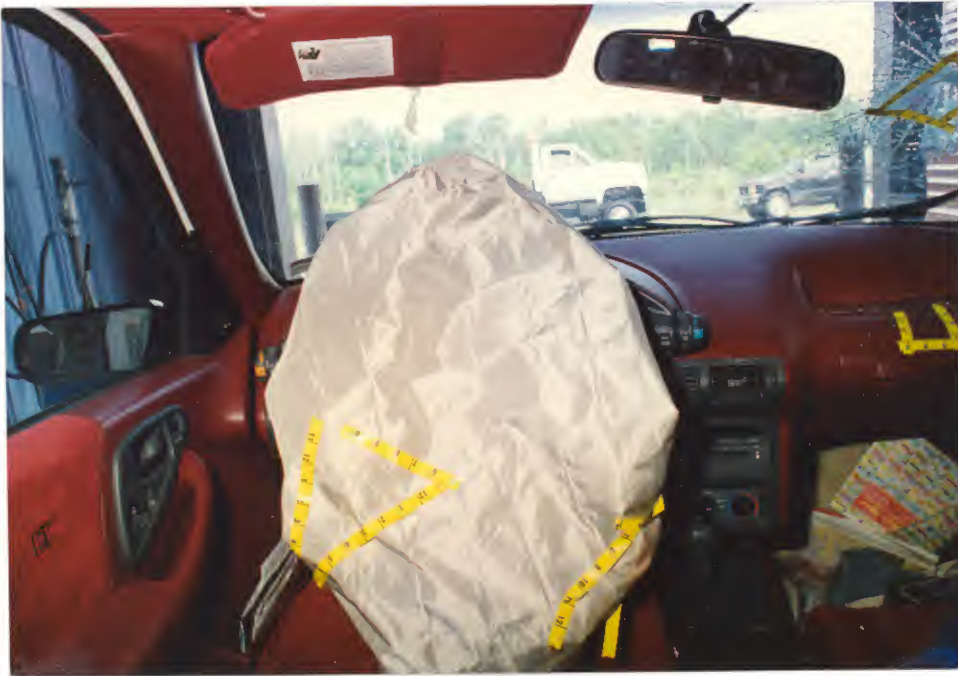
At the beginning of the vehicle inspection, the position of the steering wheel was noted in 100 degrees counter clockwise position. This position appeared consistent with on-scene photographs of the vehicle interior. The rotation probably occurred as a consequence of the impact with the drainage pipe and accentuated by the interaction of the right front tire with the side of the ditch.

43. Overall view of the driver's air bag and contact points (steering wheel rotated approximately 100 degrees CCW).

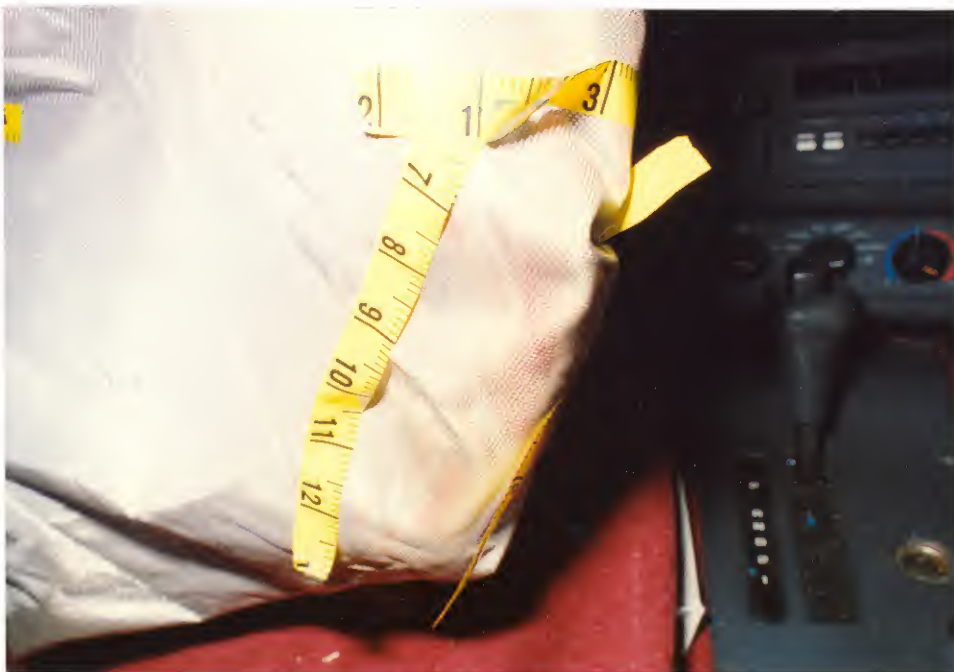
44. Close-up of bodily fluid transfer on lower left quadrant of air bag.

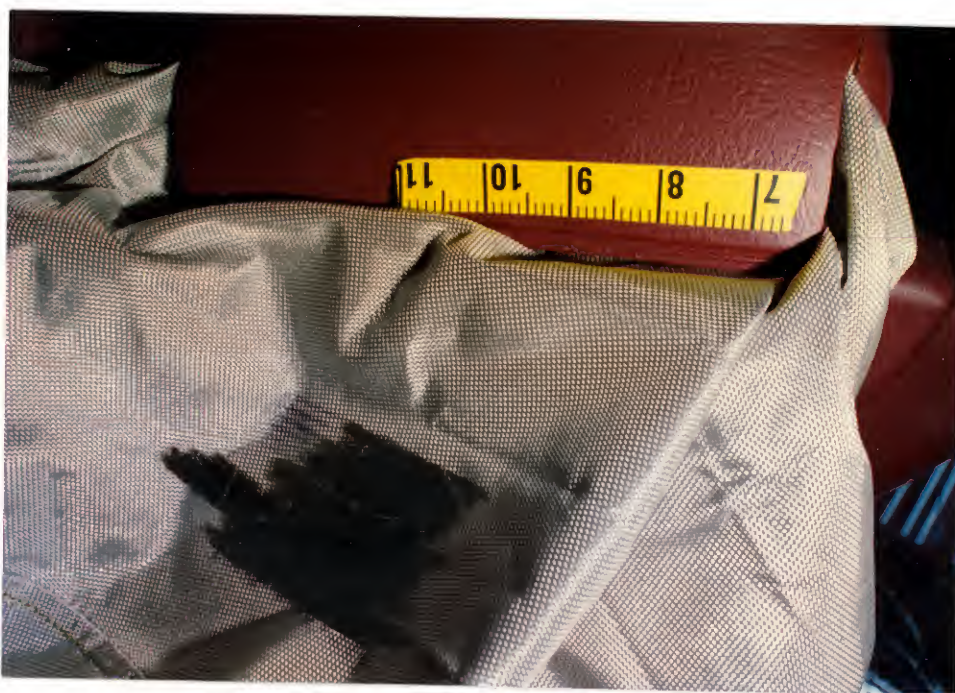
A tissue transfer located along the lateral seam line of the upper module flap began at the bottom right corner and extended 7.6 cm (3") to the left. This was attributed to contact with the driver's neck during the air bag deployment sequence. Strands of hair associated with the driver's head were observed wedged in the lower right corner of the Chevrolet insignia. This was attributed to contact by the lower flap during the deployment sequence.

46. View of upper air bag module flap showing tissue transfer along seam break.

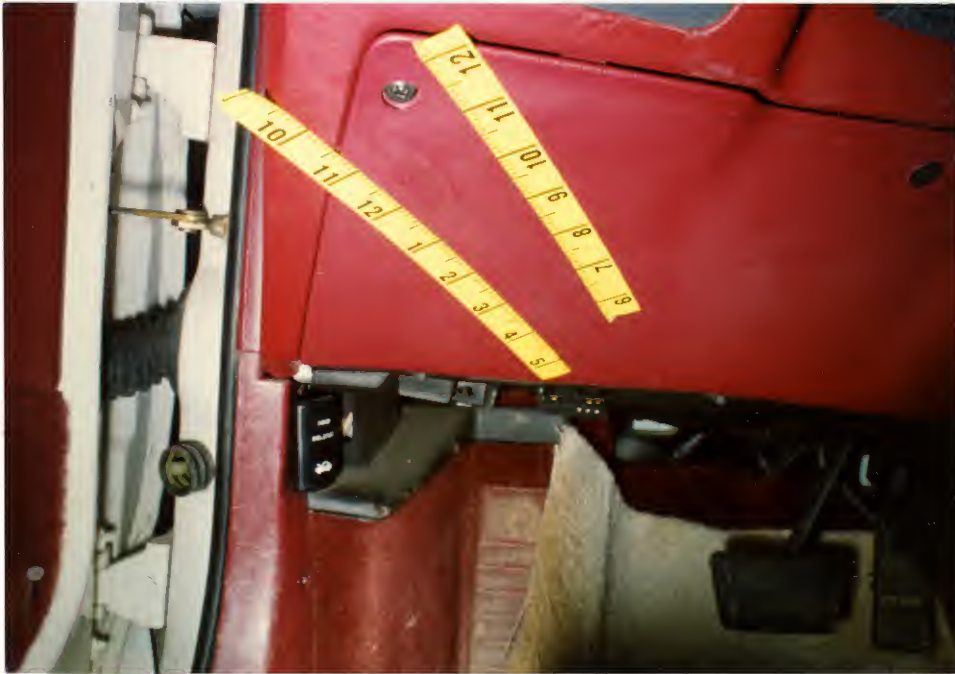
The driver was thrust rearward and contacted the seat back rest. She rebounded and contacted the lower instrument panel with her left knee which was noted by a 20.3 cm x 3.8 cm (8.0" x 1.5") scuff mark located 48.3 cm (19.0") left of the vehicle centerline (refer to photograph #47). She then contacted the inflated air bag a second time with her upper body and subsequently moved rearward and to the right as the result of the vehicle's final rest attitude (i.e., canted to the right along the ditch slope). The driver's body slumped to the right across the center console with the right side of her head coming to rest on the right front seat cushion facing forward. The driver's right arm was outstretched toward the right front door surface and situated under her head. Her lower body remained in the driver seat with her hips and thighs located toward the right side of the driver's seat cushion with her knees near the instrument panel between the steering column and console. Her right foot appeared to be resting on the floor pan and the left foot positioned diagonally toward the left side kick panel (refer to photographs #61 and #62).

47. Scuff pattern on surface of knee bolster by driver's left knee.

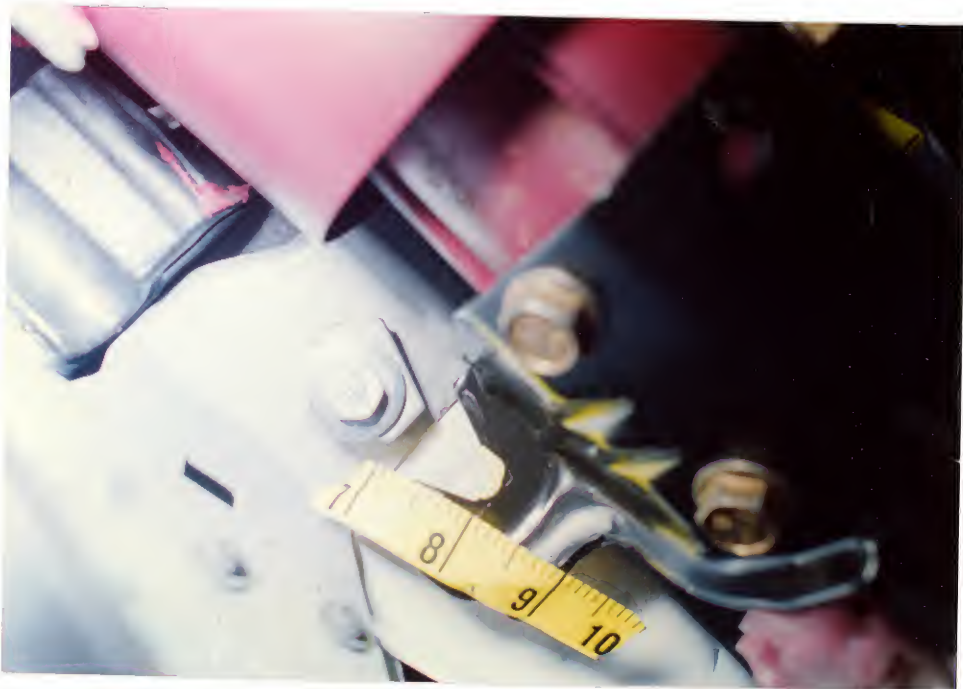
50. View of left shear capsule/shear plate showing 2.5 cm (1.0") of longitudinal movement.

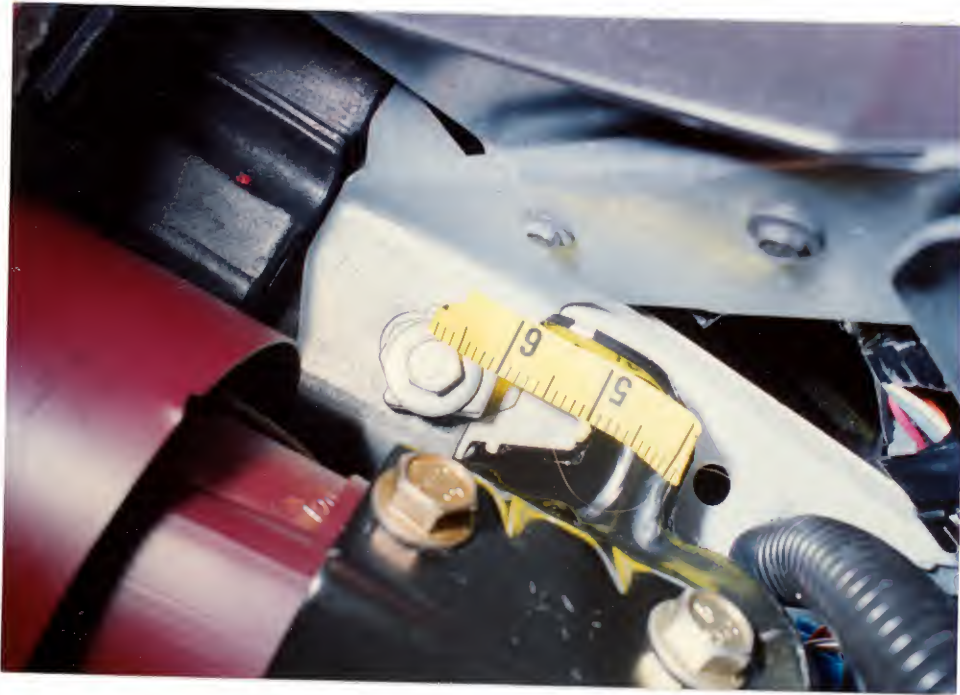
51. View of right shear capsule/shear plate showing 2.5 cm (1.0") of longitudinal movement.

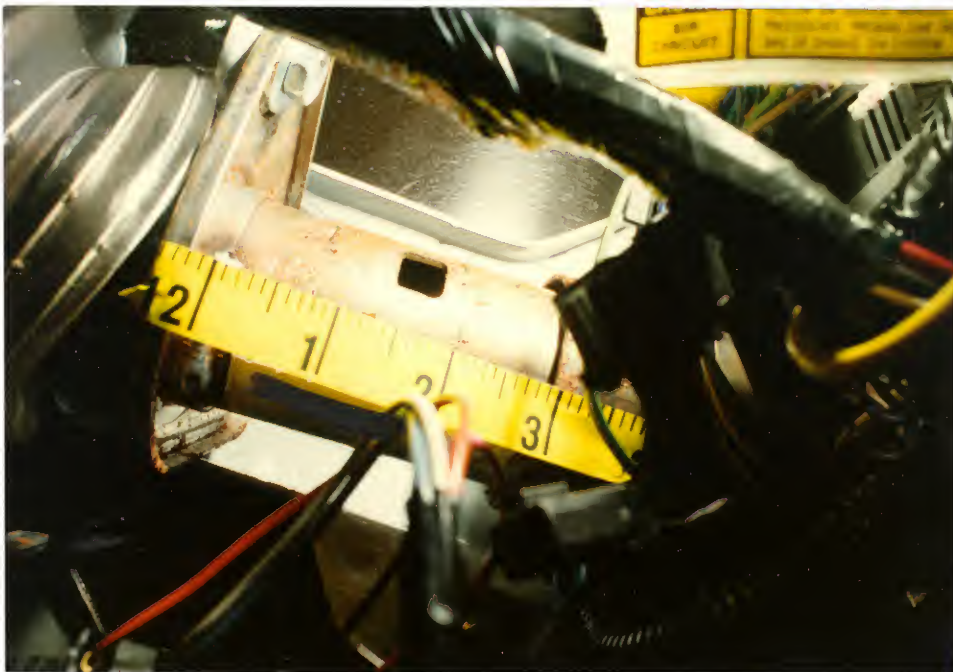
52. View of steering column EAD with 1.90 cm (0.75") of compression. The post crash measurement from female end to flange was 8.30 cm (3.25").

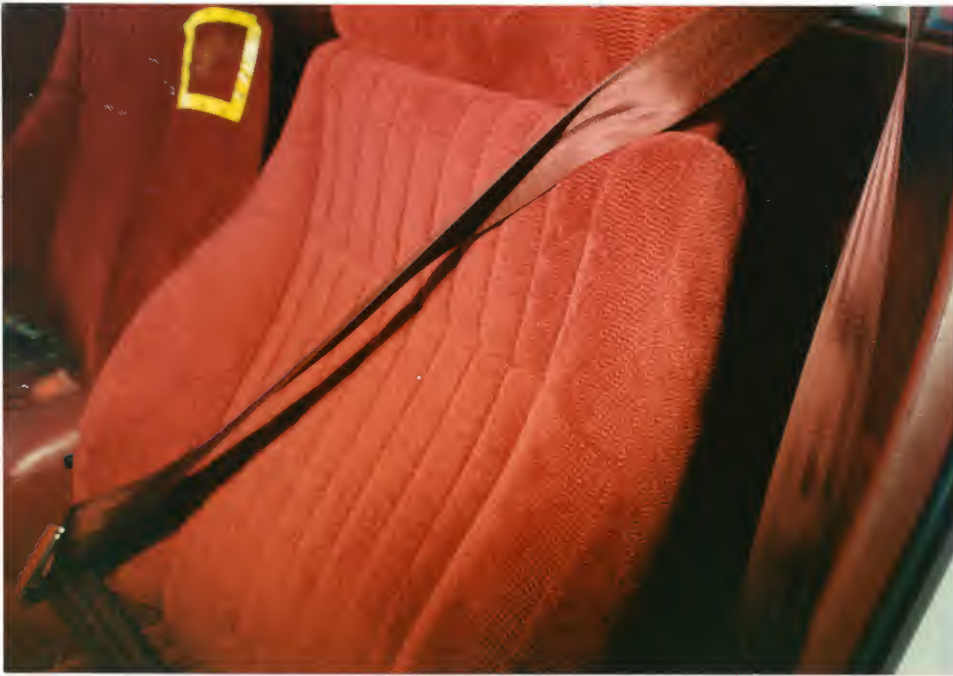
53. The driver's seat back rest with 3 point manual belt engaged to illustrate the lack of usage in crash.

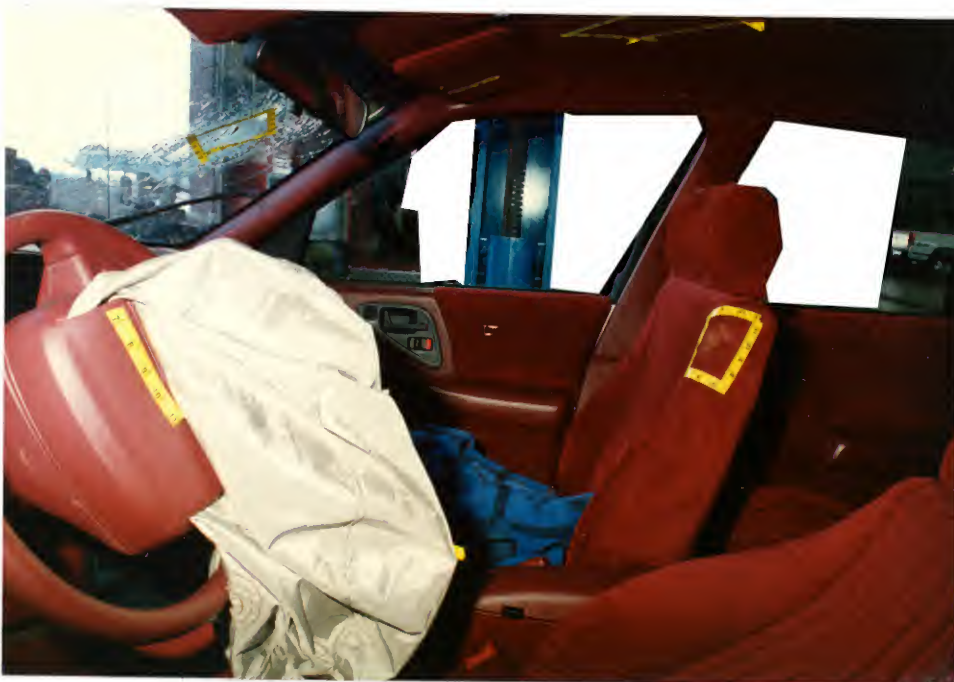
54. Lateral view of front seats from the left side showing emesis on the console side of the right front seat back rest.

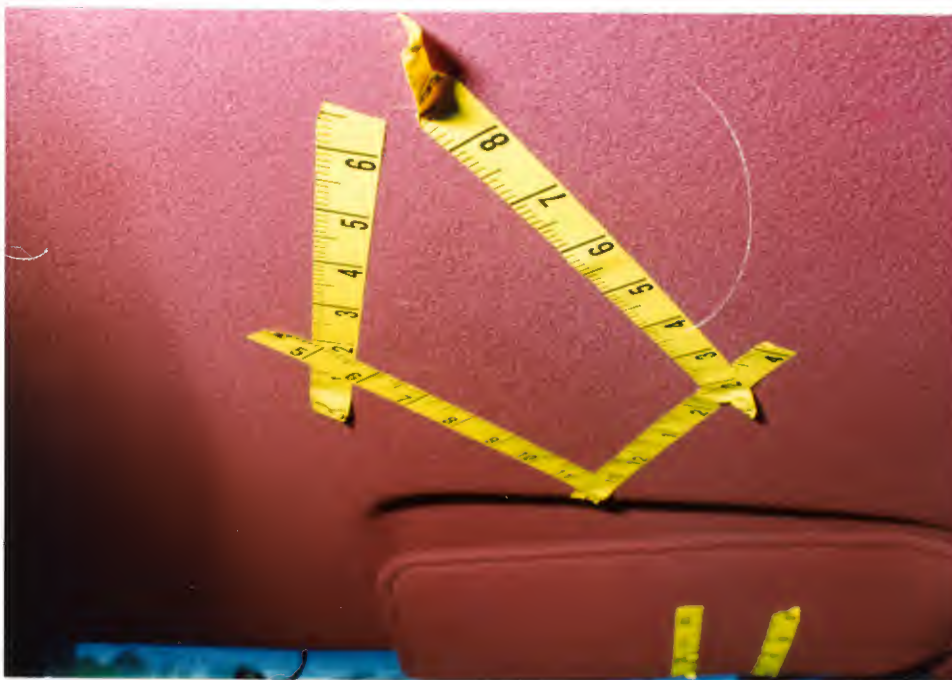
The roof liner fabric was abraded above the right front passenger's seat. This area measured 12.7 cm by 14.0 cm (5.0" x 5.5") and was located 17.8 cm (7.0") right of the vehicle centerline. The abraded mark also appeared to have a bodily fluid stain which was attributed to contact by the right front occupant during egress activities.

55. Abraded surface of roof liner fabric.

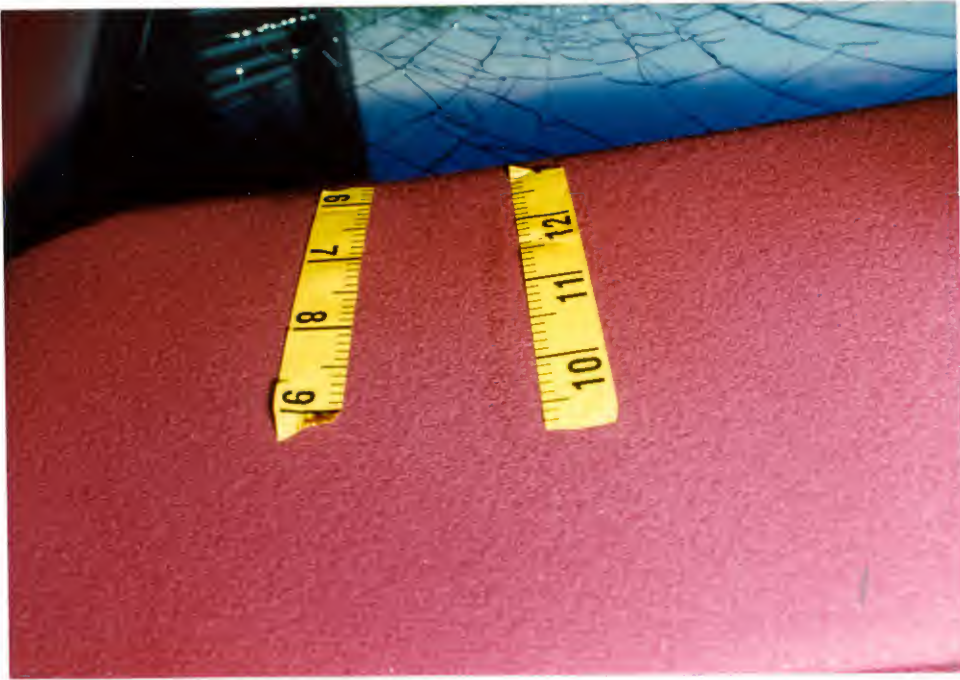
A smudge mark attributed to the passenger's upper torso was noted on the upper edge of the mid-instrument panel below the windshield. A bodily fluid transfer on the right sunvisor located 36.6 cm (14") right of the centerline was attributed to post-impact contact by the right front passenger. She was described by witnesses as covered with bodily fluid and found in the rear seat area.

57. Close-up view of right front occupant contact on right sunvisor.

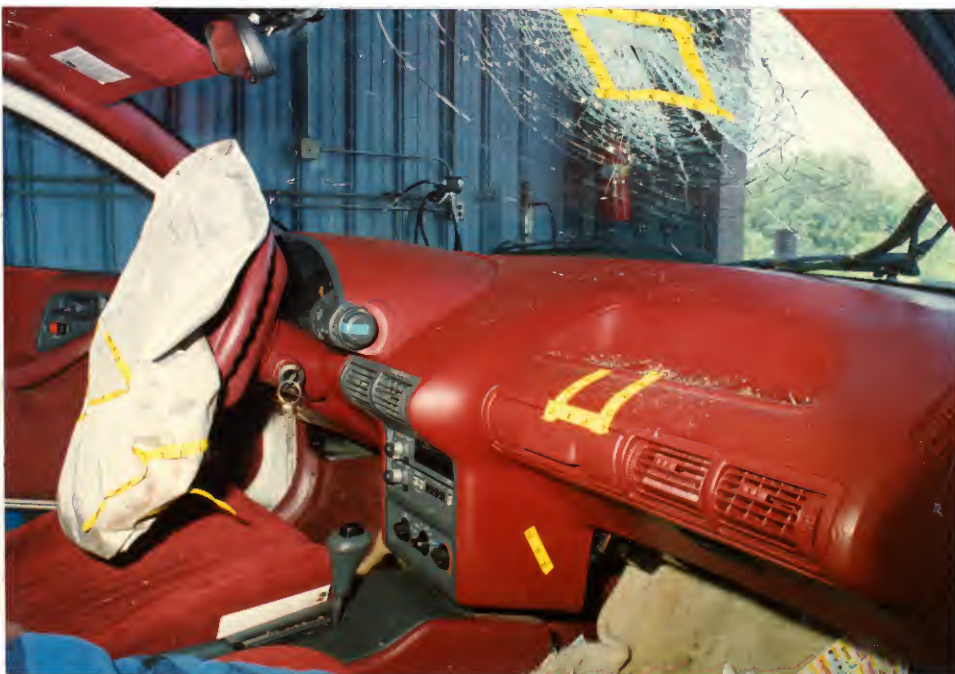
58. Angular view of the right instrument panel highlighting right front occupant contacts on the windshield and upper instrument panel.

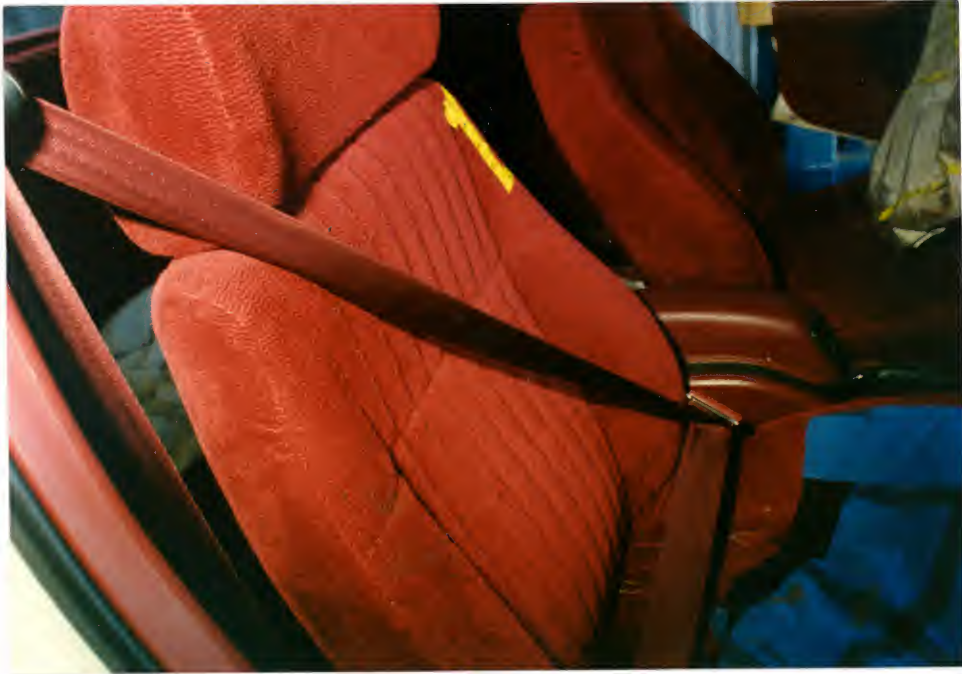
59. View of the right front seat with the 3 point manual restraint belt engaged to illustrate lack of usage in crash.
